August 24, 2012

SR1 Fume Hood leak preliminary investigation report

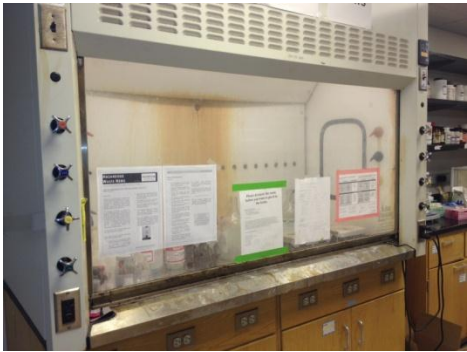
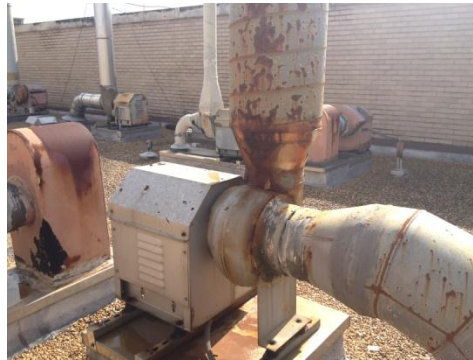
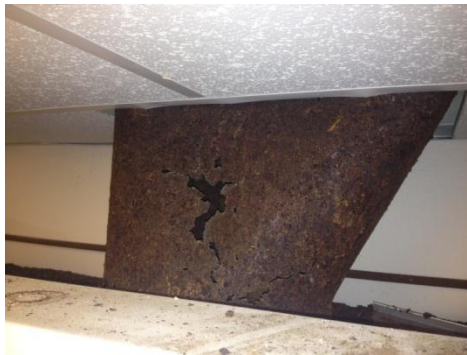
PICTURES OF EXHAUST SYSTEM IN ROOM 51D

On August 22, 2012 NSM reported another similar leak in the Dean's Business office area (Room 209). This leak seems to be coming from the weld seam of the exhaust duct work. After noticing two similar leaks within few weeks, FM decided to investigate the remaining systems in the building on August 24, 2012 and found one other area with severe deterioration (Room 51D) in the basement.

Attached are some of the pictures taken in SR1 room 51D - fume hood and the building exhaust visibly showing the rust and deterioration due to age and environment.

IMMEDIATE: We recommend adding Rooms 51D and Room 209 to Cotton's repair scope previously submitted for room 33 only and replace the existing ductwork connecting the fume hoods to the exhaust fans (both horizontal and vertical runs). We recommend using schedule 80 PVC for the ductwork and replacing the three dedicated exhaust fans serving these three areas. The new exhaust fans will need to be epoxy coated (or PVC depending on the size). **Note: the ductwork for room 51D will have to be redone from the basement to the 7th floor roof. This would be a CRDM expense and we will send the issues summary once we have the proposal for committee vote.**
