## CRDM Committee Meeting

University of Houston M. D. Anderson  
Library Water Infiltration Issues

WALTER P MOORE

# PHASE I & II - NORTH ELEVATION

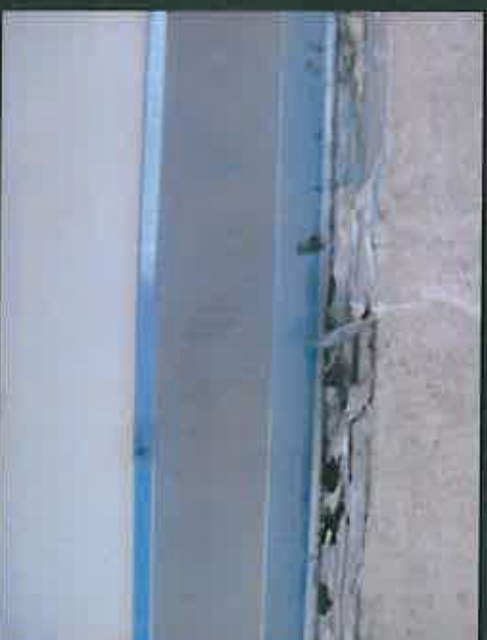
Photo 2: Failed sealant above metal flashing

- Replace parapet coping
- Repair flashing at roof
- CMU repointing at parapet
- Repair parapet transition between CMU and concrete
- Stone repair
- Install new joint sealant at all stone-to-stone joints and stone-to-window joints
- Install new wet glazing at all windows
- Clean and coat corroded steel framing
- Remove deteriorated gypsum board
- Replace fogged glass

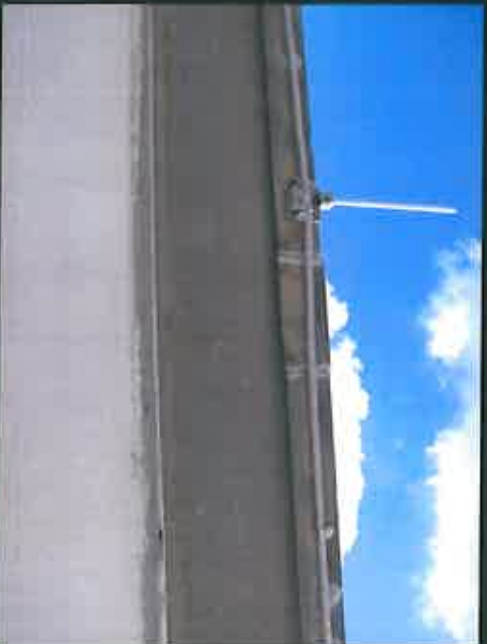
Photo 3: Distressed parapet wall coping

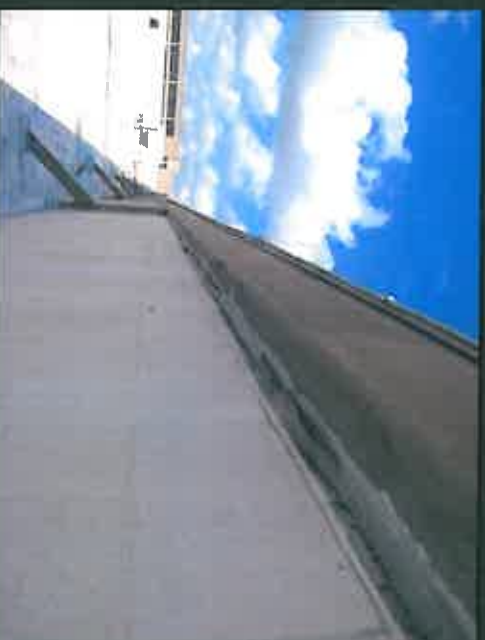
Photo 4: Failed joint sealant below parapet framing

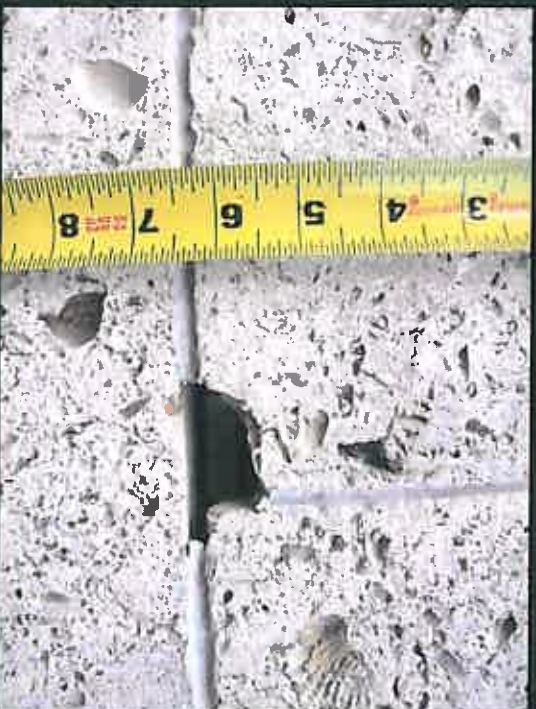
Photo 1: Typical spall in stone veneer

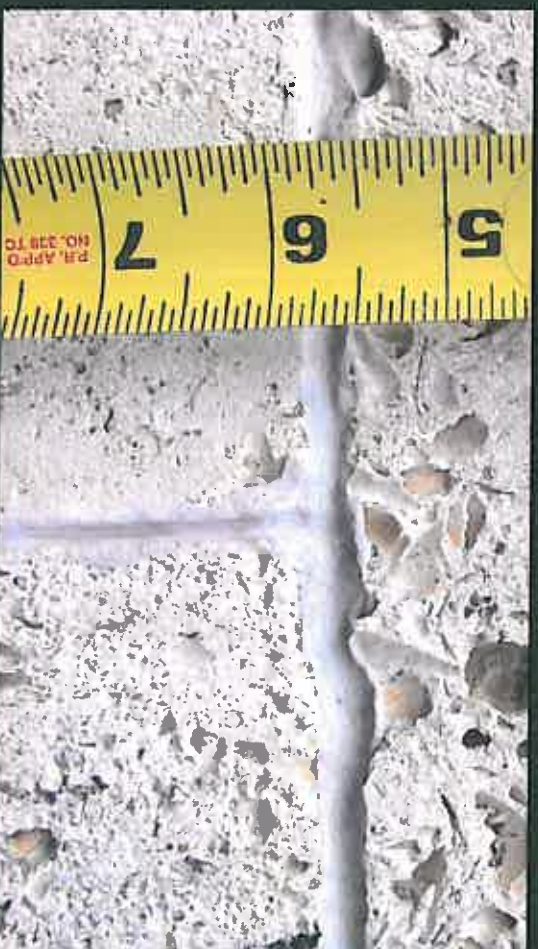
Photo 3: Deteriorated stone-to-stone joint sealant

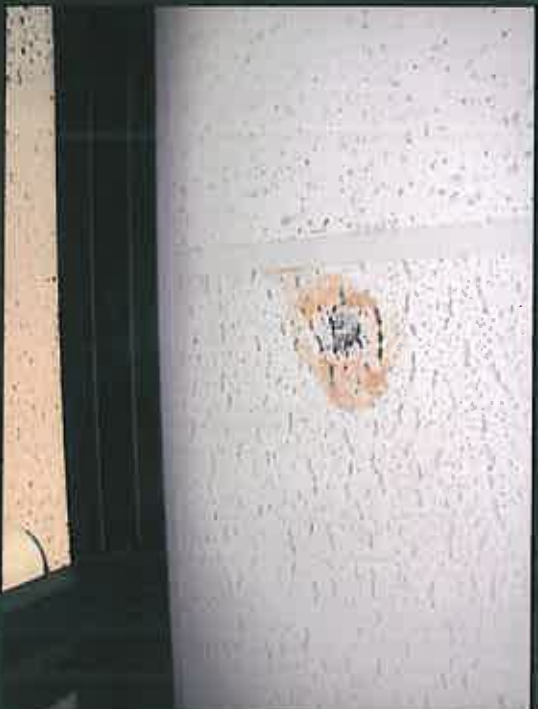
Photo 1: Water-stained ceiling tiles

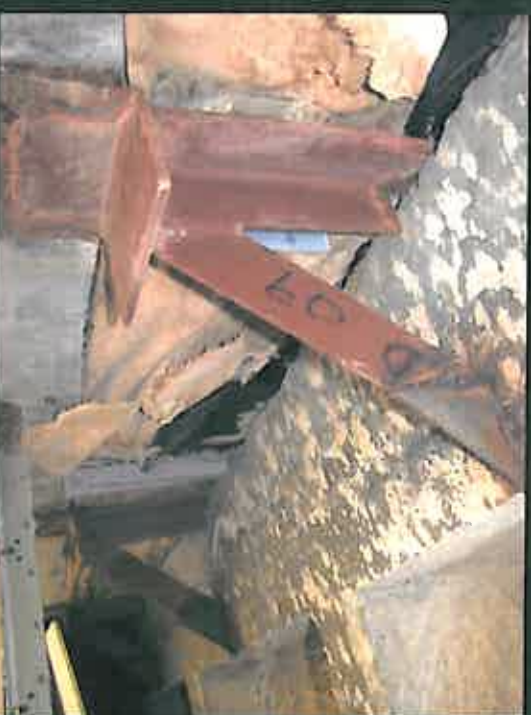
Photo 2: Deteriorated Sheathing (above windows)

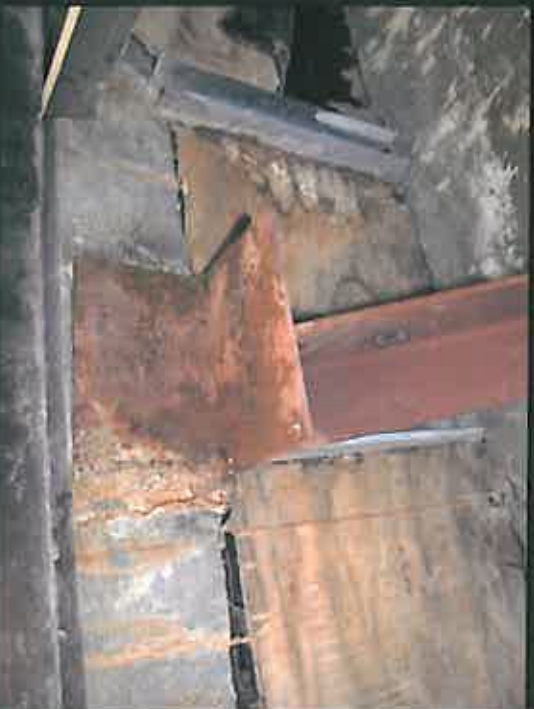
Photo 3: Corroded steel angles (above windows)

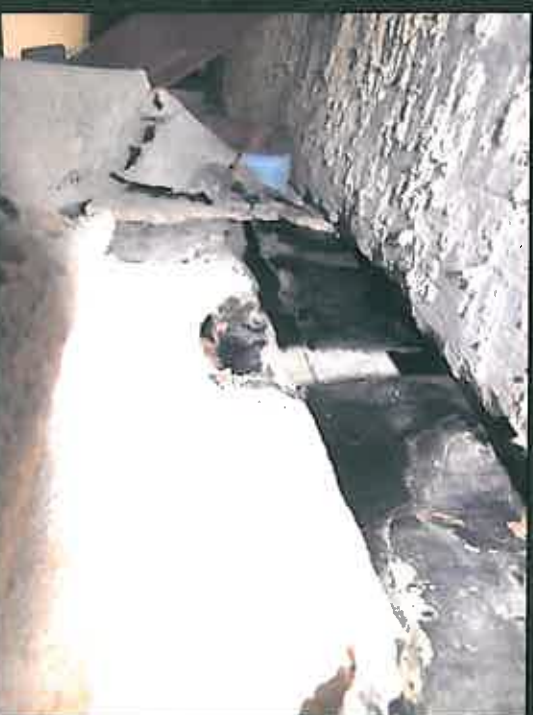
Photo 4: Damp-proofing not properly lapped

- Remove all stone above and below windows
- Replace gypsum board
- Install waterproofing and flashing
- Reinstall the stone that was previously removed
- Lateral connections may require upgrade
- Lintel replacement may be required in some areas
- Construction: 6 months

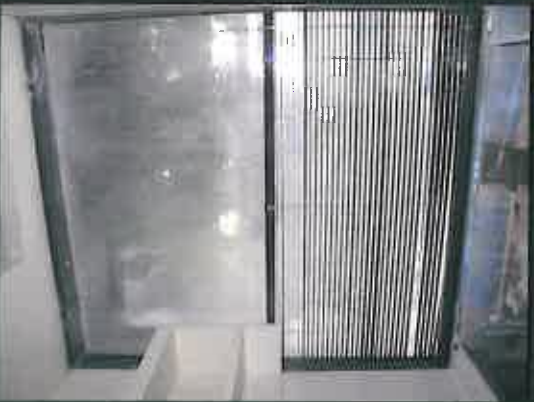
Photo 1: Moisture between window panes

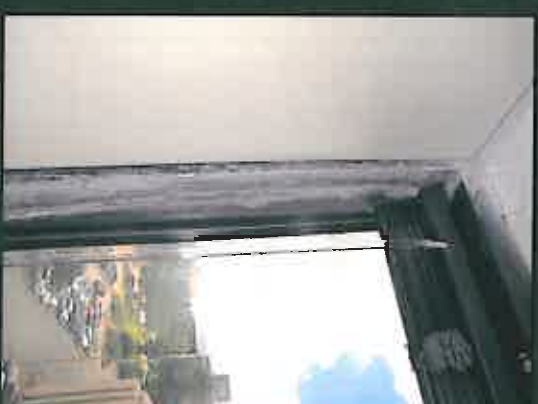
Photo 2: Moisture staining on window framing

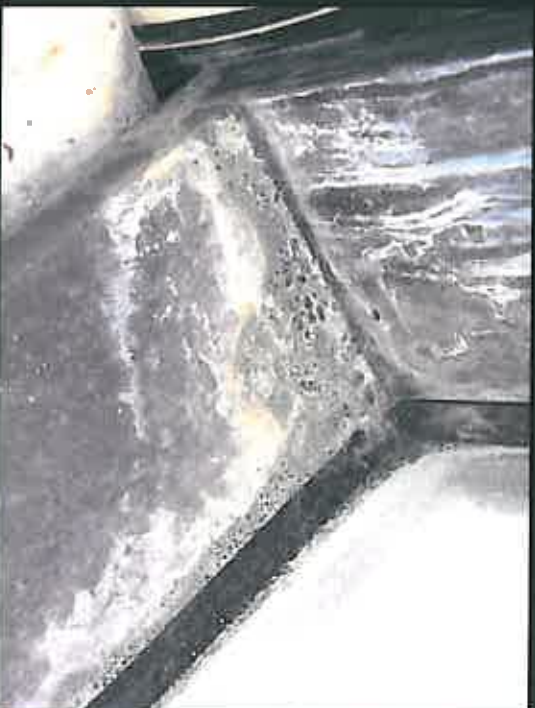
Photo 3: Moisture staining on window framing

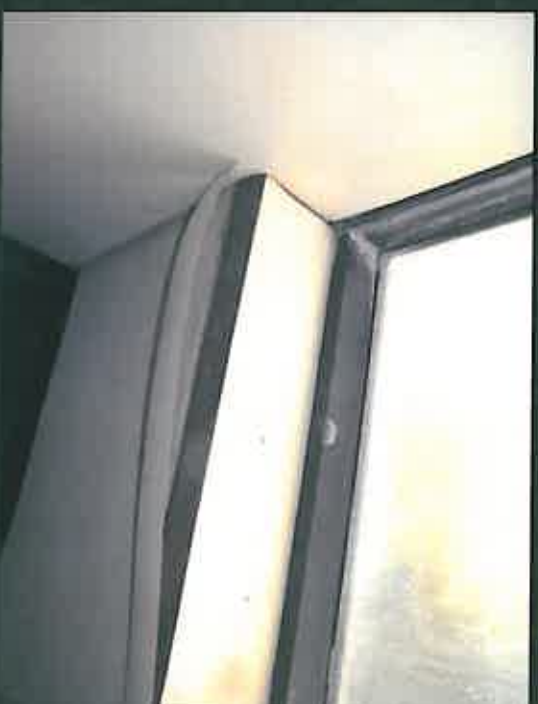
Photo 4: Delaminated vinyl below window sill

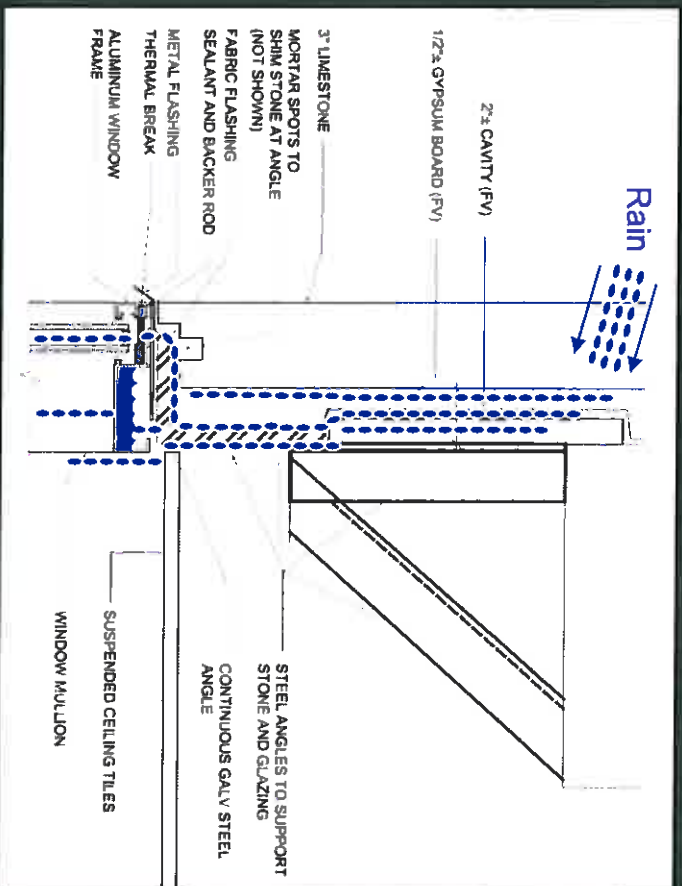
Approximate As-Built 'Top of Window' Detail  
(as observed in the field)

- Façade is designed as a cavity wall system.
- The absence of weep holes does not allow moisture that penetrates the exterior wall surface to exit the wall cavity.

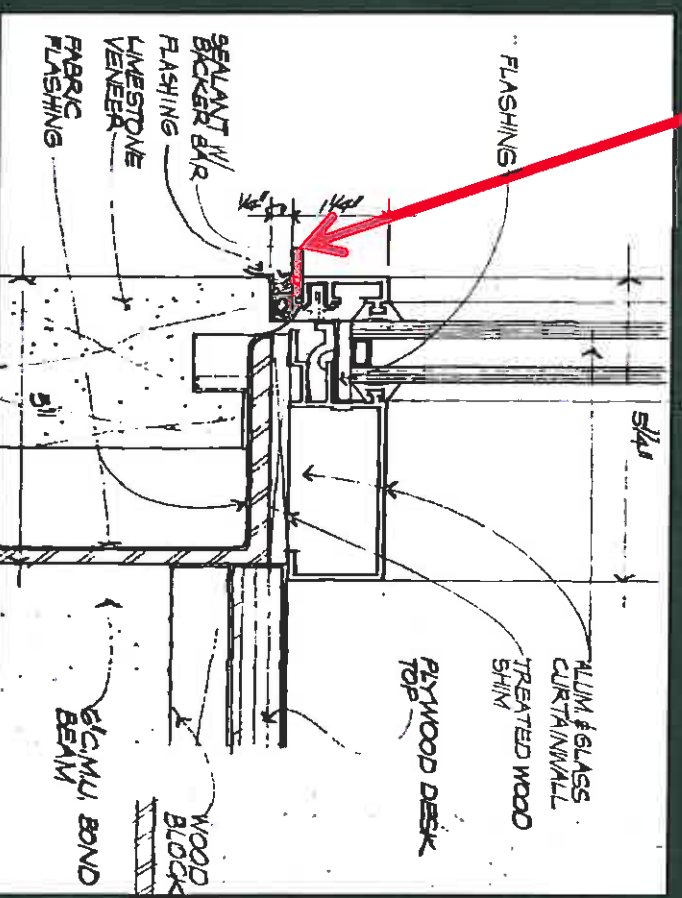
'Bottom of Window' Detail  
(taken from record drawings)

Post-installed  
tube weeps
