## CRDM Committee Meeting

University of Houston M. D. Anderson  
Library Water Infiltration Issues

WALTER P MOORE

# PHASE I & II - NORTH ELEVATION

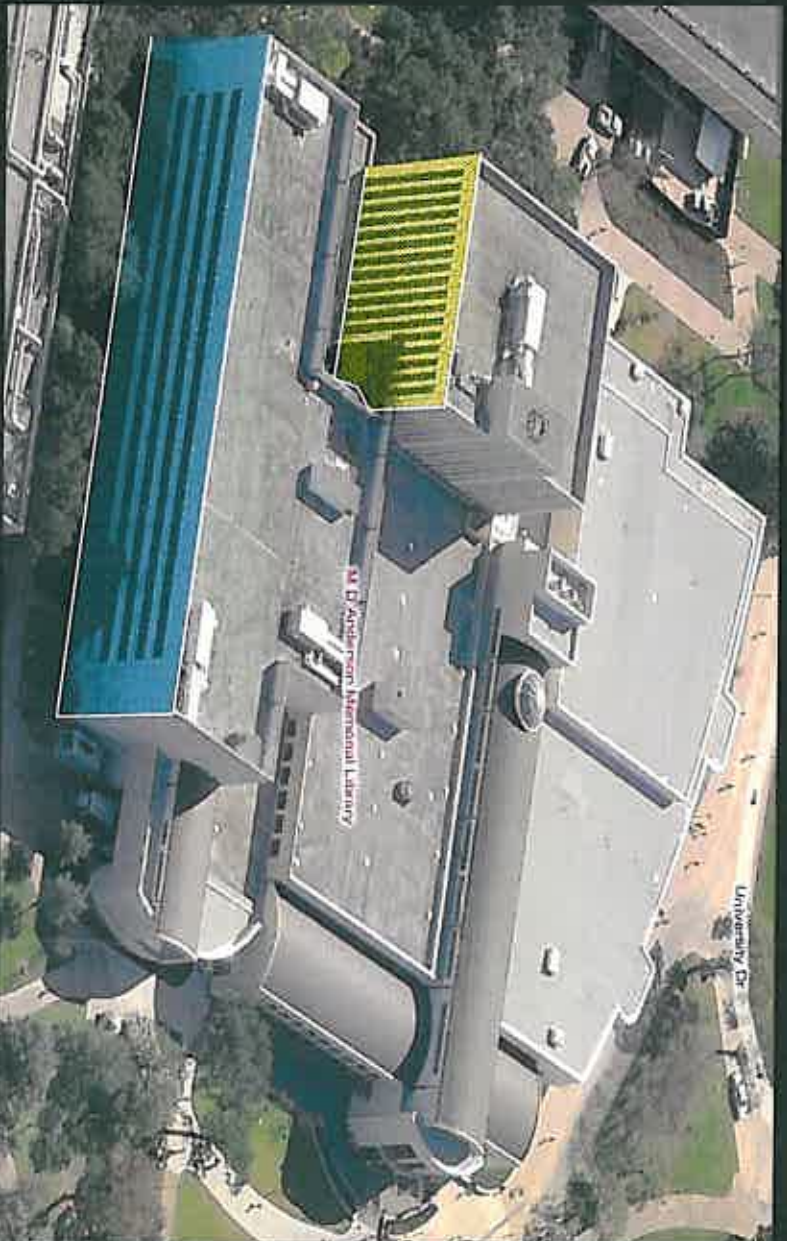
- Interior moisture infiltration observed at multiple locations at the M. D. Anderson library
- Limited previous maintenance of building envelope
- Previous façade repair documentation not available for Engineer review
- Most significant signs of moisture infiltration at the north elevation

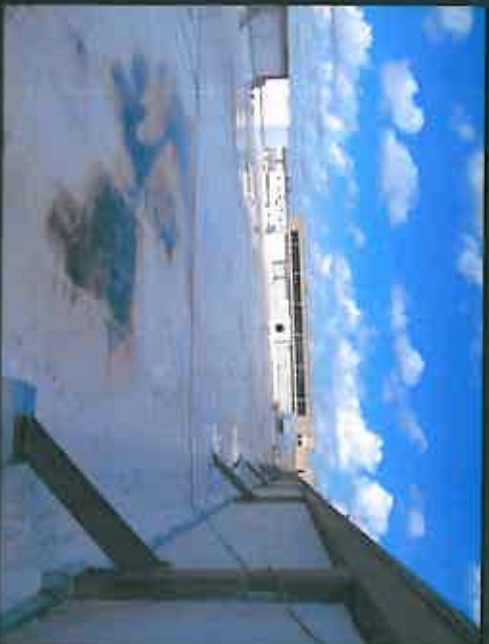
Photo 1: Overall view of Roof Level
